The International POPs Elimination Project

Hotspot report for Pattern of Practices: PCBs Sources and Releases in Tanzania

AGENDA for Environment and Responsible Development (AGENDA)

April 2005

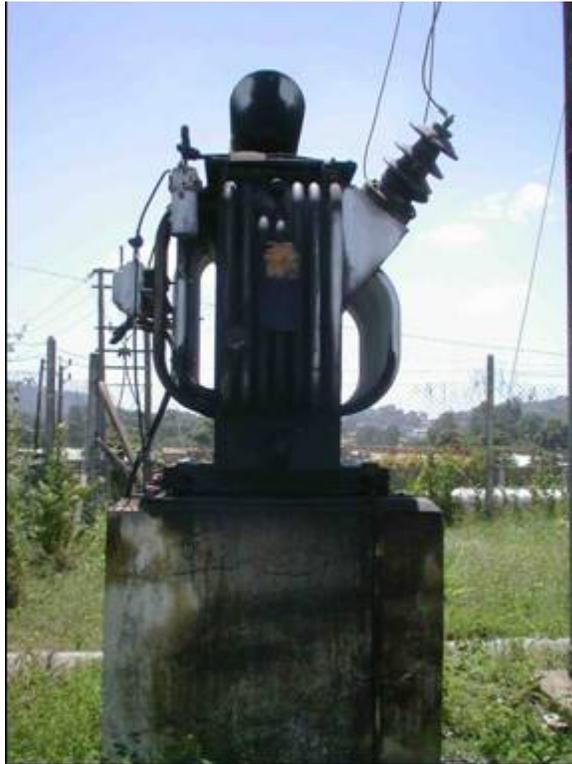
P1: A distribution transformer at a substation near TBL in Arusha

Leaks/spills typically occur in transformer when the stopcock, seals and gasket joining the top to the body corrodes, tears, or physically fails. PCBs can then leak past this failed section and potentially spill onto the surrounding ground. In addition, leakage may occur due to defects by mechanical and accidental damage in the metallic structure or outer casing of the transformer². The damage may render the casing more liable to attack by acidity in the oil. This acidity may then cause internal corrosion at the weaker parts of the transformer, even if it is apparently in satisfactory condition. These weaker parts are the transformer cooling fins that are manufactured by bending, forming and possibly welding. These operations can cause stresses and weakening of the structure and increase the chances of corrosion and then leakage (see plate 1).

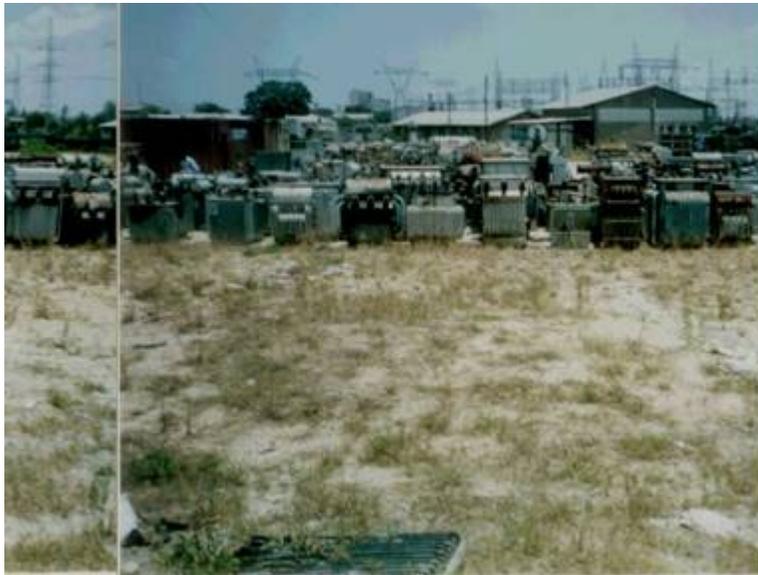
P2: Out of service transformer stored outside the Ubungu Central Workshop

In some cases, waste transformer oil is stored, but the storage facilities are of inadequate size to accommodate the whole amount of the waste oil available on site; some of storage containers for transformer oil are leaking. The storage facilities also do not have concrete floor. At some sites, the storage sites are too close to water bodies, residential areas and farms, e.g. at Ubungo Electric Workshop (see plate 2).

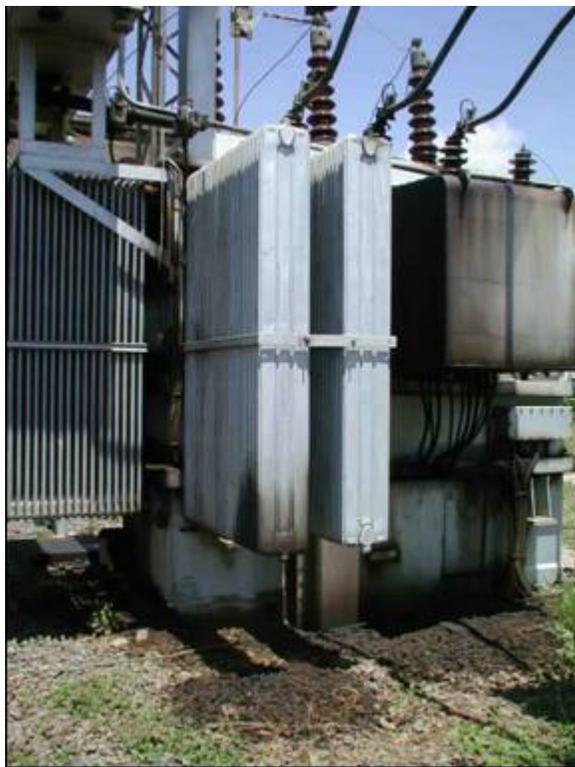
P3: Power transformer at a substation located at the Old power station Arusha, Unga Limited area

In Ubungo Electric Workshop in Dar es Salaam and KILTEX Sub Station in Arusha the storage facilities for transformers are the open type, which results in a weathering effect on the material of the equipment and causes leaks as shown in plate 3. Also, unavailability or inattentive follow-up of maintenance schedules results in heavy leaking transformers in most of the sites (see plate 4). For

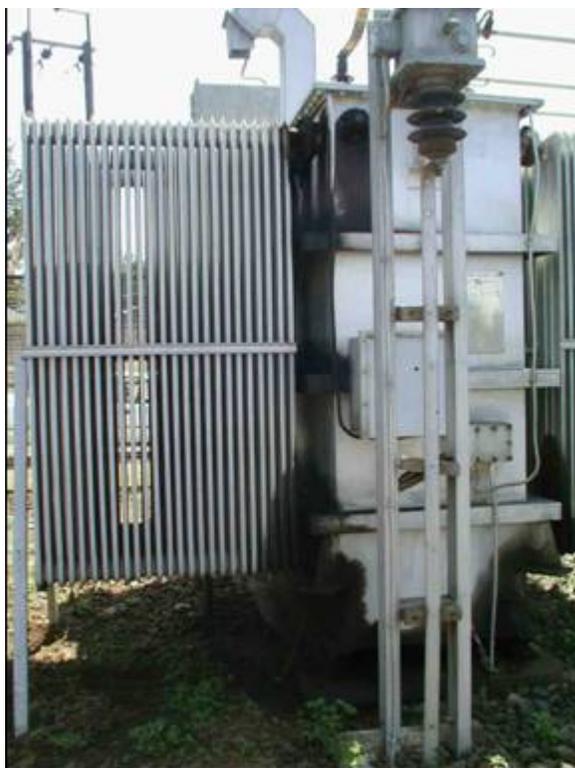
P4: 132 KVA Power transformers at Kivungi Substation, Moshi

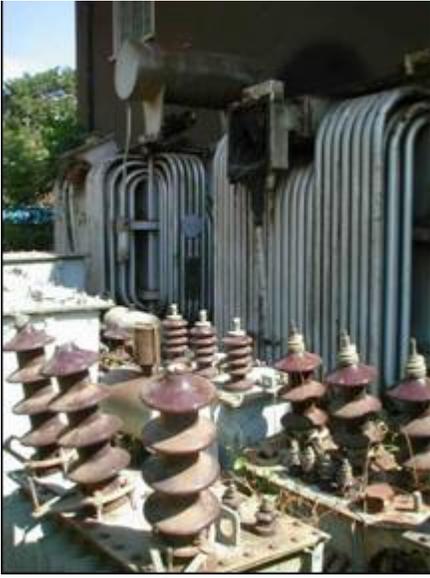
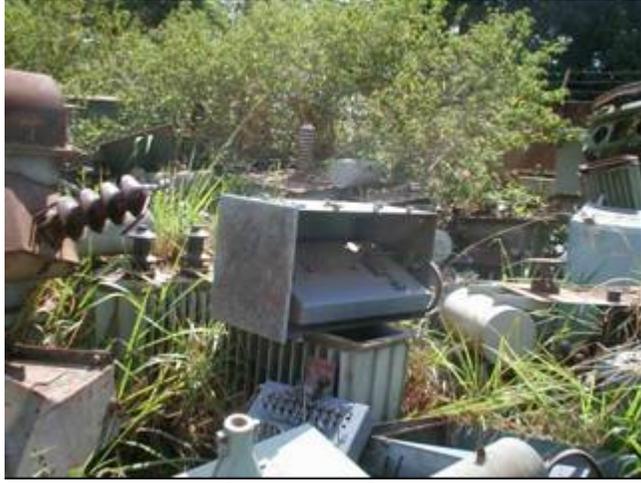
P5 and P6: Out of service transformer stored at the Old Power Station in Moshi.

In most sites waste oil is disposed of haphazardly and occasionally given away to individuals. Generally, there is no proper disposal mechanism of the waste containing PCBs oils including contaminated solids, obsolete / defective / decommissioned transformers, capacitors, switch gears, circuit breakers, filters and residues from electrical equipment in most of the sites as shown in plates 5 and 6.

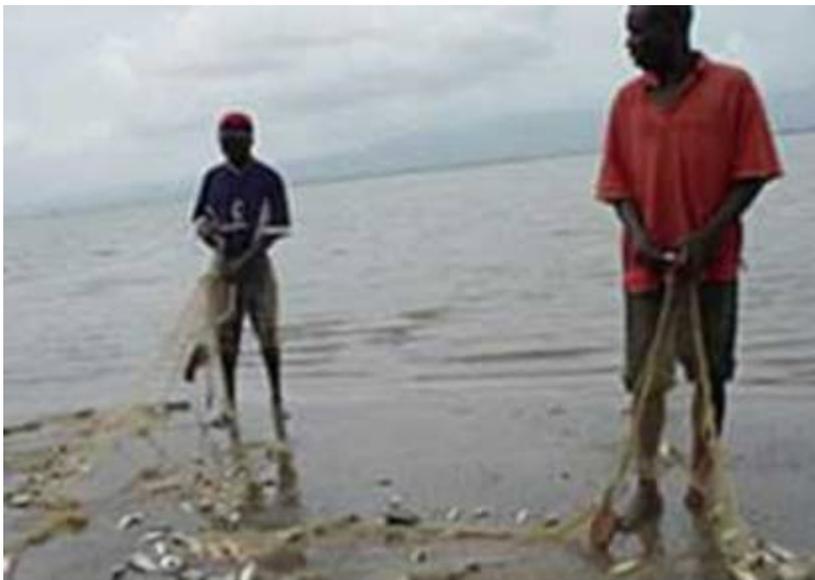
P7: Fishing at Nyumba ya Mungu: key to the local culture and economy

Transformers at Old Pangani and Nyumba ya Mungu are also leaking. After the power generation the water is released to downstream users. Members of community use this water for irrigation and domestic purposes. At the dam of Nyumba ya Mungu there are fishing activities as shown in plate 7, which means that many people are exposed to PCB ingestion.

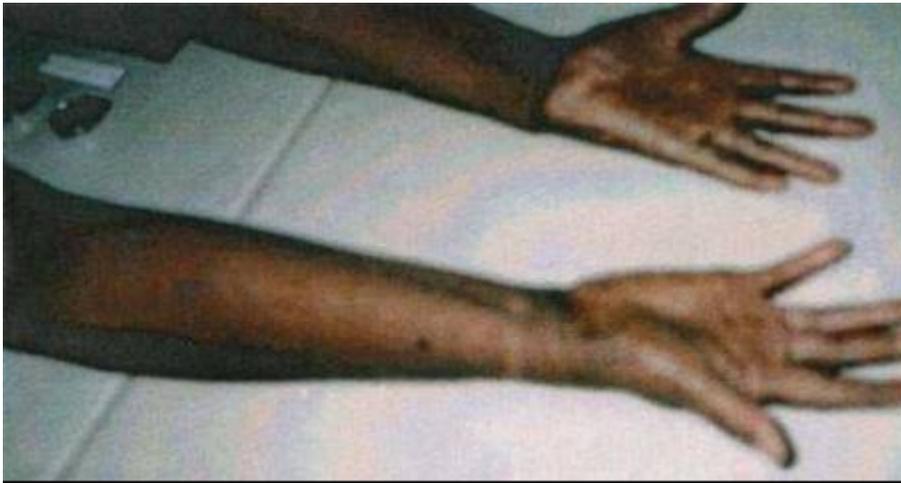
P8: A lady working at DIA suffered skin ailments due to contact with PCB oil

Most of the personnel dealing with electrical equipment containing transformer oils which containing PCB are not aware of health hazards associated with PCBs. It is common practice to handle such oils with bare hands, health impacts not withstanding. Plates 8, 9 and 10 show a lady who worked at the Dar es Salaam International Airport (DIA) with skin ailments. The condition could be related to improper handling of PCBs. Five (5) transformers with PCBs (Askerel) were found at the DIA.

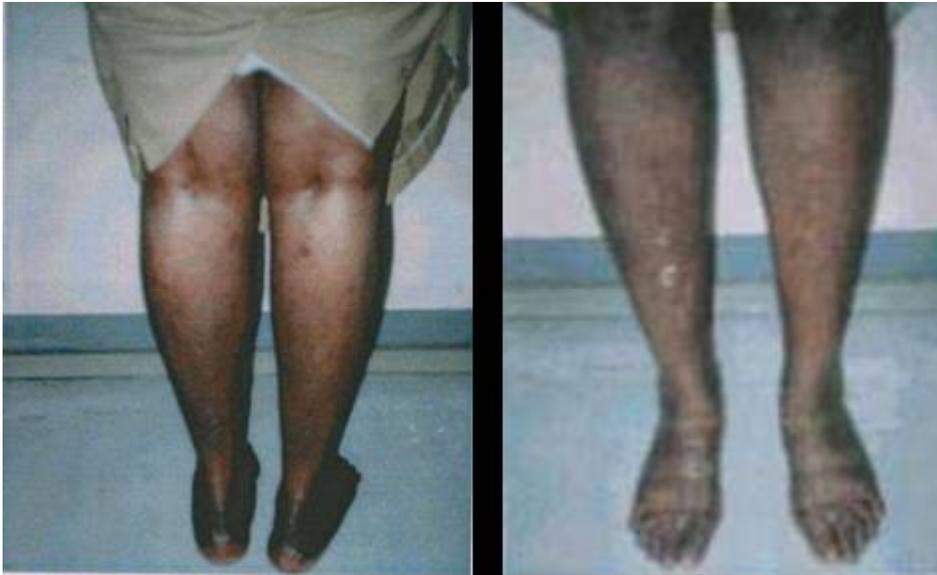
P9 and P10: A lady working at DIA suffered skin ailments due to contact with PCB oil
